# External Coating for Airport Jet Fuel Pipeline

ID: 9008

Industry: Oil & Gas  
 Application: VPF-Valves, Pipes and Fittings  
 Substrate: Carbon steel  
 Products: Belzona 5831 (ST-Barrier)

Customer Location: Dubai, UAE  
 Application Date: December 2022

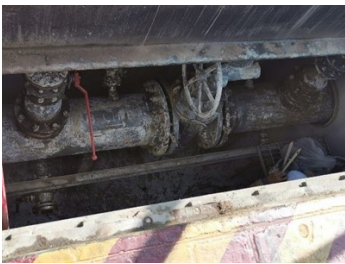
The facility manager responsible for the airport's infrastructure found problems related to the jet fuel pipeline. Corrosion has been detected, posing a significant risk to the safety and reliability of the pipeline.

Original condition of the corroded pipeline

The application was carried out in accordance with Belzona Know-How System Leaflet VPF-2 and two coats of Belzona 5831 was applied. As hot work was prohibited, manual surface preparation was carried out. No damage was caused by this process.

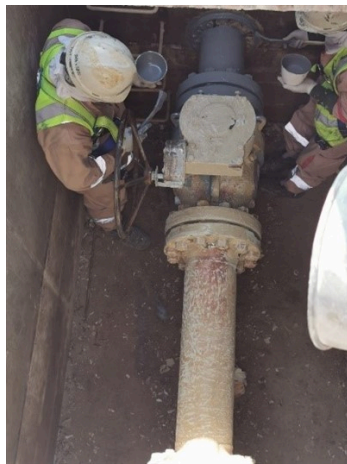
Application in progress

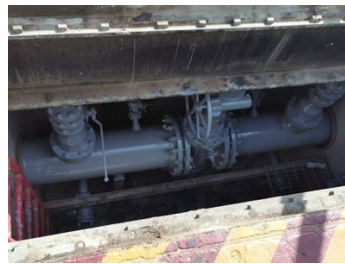
Application completed
