Belzona repairs vessel skag

ID: 9009

Industry: *Marine*
Application: *SOS-Ships and Offshore Structures*

Customer Location: *Scotland*
Application Date: *March 2023*

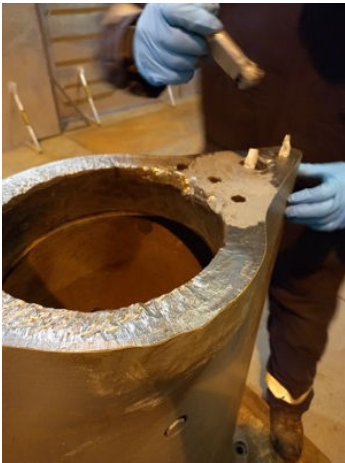
Surface preparation carried out & Belzona 1111 applied

The corroded areas were prepared using grinding tools to get back to bare metal & to roughen the surface. Belzona 1111 was then applied ~2mm proud of the surface. Applicator tools were used to form the inner bearing surface. Once the Belzona 1111 had reached its initially cure stage it was machined back down to the original equipment dimensions.

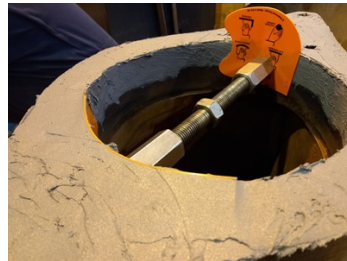
Close up of inner edge forming
