BELZONA® 2141 PROTECTS FRANCIS TURBINE RUNNERS FROM CAVITATION

Customer Location: Hydroelectric plant (Ontario, Canada)
Application Date: August 1998 and July 2001

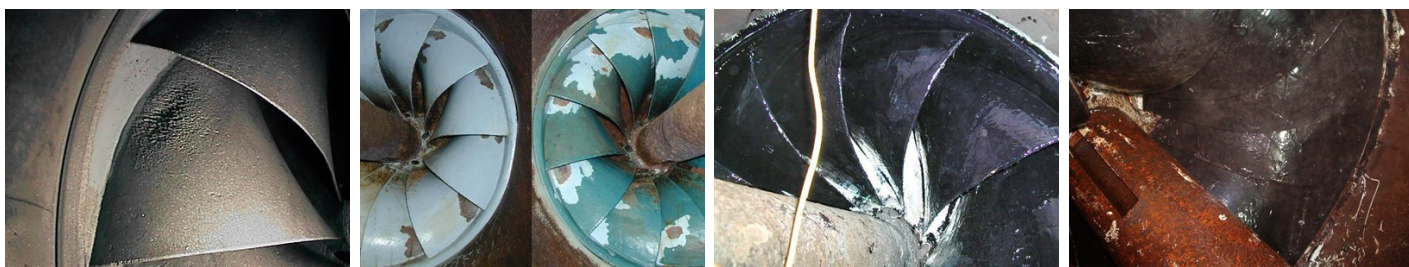
Photograph Descriptions

Cavitation had caused erosion of the parent metal and loss of performance of the turbine. Belzona® 1341 and Belzona® 1421 had been applied in 1998 but had suffered erosion in this aggressive environment.

- * Cavitation damage ,
- * Belzona® 1341 (left) and Belzona® 1421 (right) after 36 months service ,
- * Belzona® 2141 after application ,
- * Belzona® 2141 after 34 months ,

Twin 914mm (36 inch) Francis Turbine Runners operating with 13m (42 feet) head and constructed in 1945.

Inspection of the Belzona® 2141 in 2002 showed no damage – further inspection after 34 months showed no sign of damage to the coating.
