# Belzona Saves Daycare \$30k with 2311

ID: 9022

Application: FPA-Floor Problem Areas

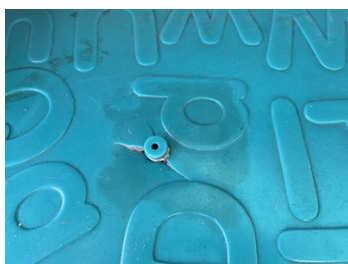
The customer was facing a challenge with their 20-year-old hard plastic playground flooring. Over the years, five "blow holes" in the flooring had been designed to release air as children played on the surface. However, these air holes eventually became flexible and developed cracks around their bases, posing a safety risk to the children. There was a concern that small fingers could become trapped or injured due to these compromised areas.

Blow holes with cracks formed around it

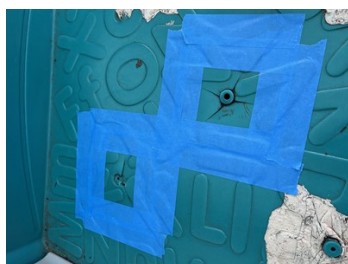
Preparation of the application area

Given that the playground floor was made from a material we don't typically bond to, it was crucial to create a suitable surface profile for the repair. To achieve this, we first taped off the surrounding areas to maintain a clean, aesthetic appearance. Then, we

used the Belzona roughing brush to create a "hairy" texture on the surface, ensuring a strong bond with the elastomer.
