Sealing of the High School Orchestra Pit

ID: 9025

Industry:	Buildings & Structures	Customer Location:	Washington, NC
Application:	FPA-Floor Problem Areas	Application Date:	February 2023
Substrate:	Concrete		
Products:	Belzona 3121 (MR7), Belzona 4111 (Magma-Quartz), Belzona 5811 (Immersion Grade)

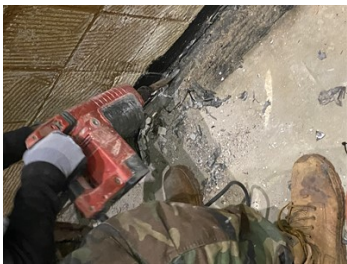
Preparing the surface

Old repairs were removed with the use of hand tools. Cove was build using Belzona 4111 and then sealed with Belzona 3121. Two-coat system of Belzona 5811 was then applied to entire orchestra pit.

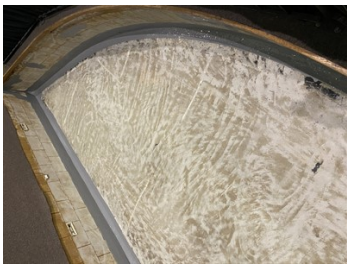
4111 and 3121 application

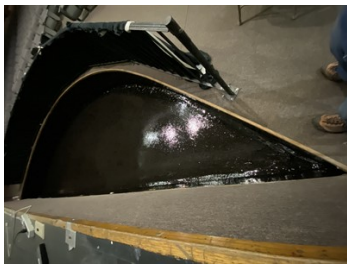
5811 top coat was applied
