Sealing of the High School Orchestra Pit

ID: 9025

Industry: Buildings & Structures
Application: FPA-Floor Problem Areas
Substrate: Concrete
Products: Belzona 3121 (MR7), Belzona 4111 (Magma-Quartz), Belzona 5811 (Immersion Grade)

Customer Location: Washington, NC
Application Date: February 2023

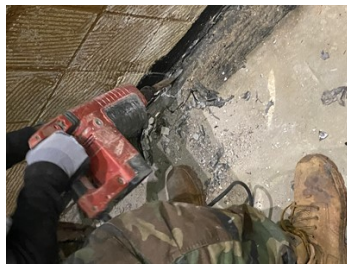
Preparing the surface

Old repairs were removed with the use of hand tools. Cove was build using Belzona 41111 and then sealed with Belzona 3121. Two-coat system of Belzona 5811 was then applied to entire orchestra pit.

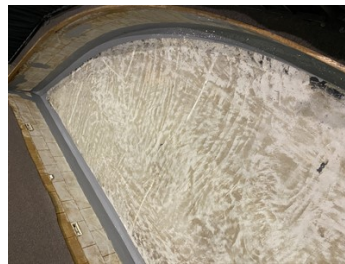
4111 and 3121 application

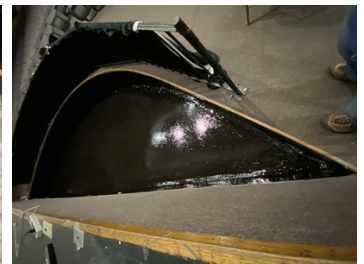
5811 top coat was applied
