# Aluminum Catwalk - Food Plant

Application: FPA-Floor Problem Areas

Substrate: Aluminum

Customer needed to repair and prevent future degradation of a large elevated catwalk surrounding a potato fryer.

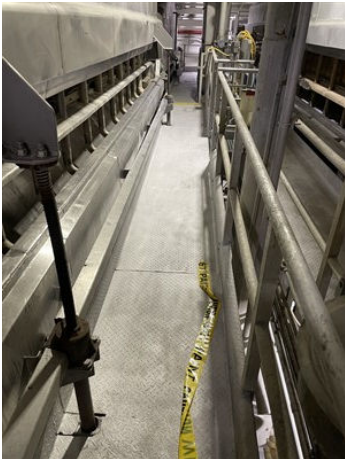
Grit blasted aluminum prior to cold bonding and coating.

Aluminum was Grit blasted to a minimum 3 mil profile for cold bonding and coating system.

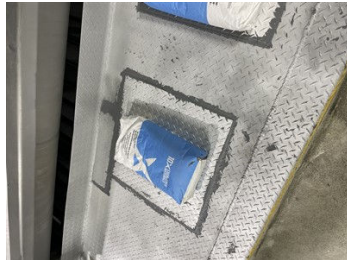
Aluminum plates used to reinforce thin wall or thru-wall area on the walking surface.
