# Belzona Makes 50 Year Old Sand Filter Pumps Feel Young Again

ID: 9027

Industry: Marine  
Application: CEP-Centrifugal Pumps  
Substrate: Bronze  
Products: Belzona 1311 (Ceramic R-Metal), Belzona 1331

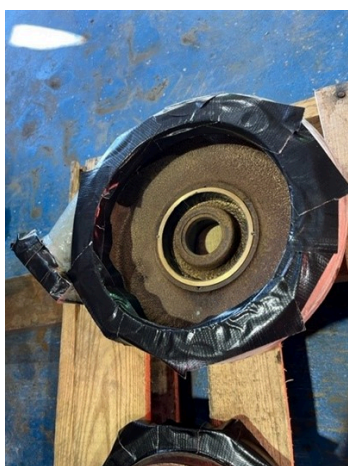
*These 50 year old pumps were getting very close to their end of life from sand filtering water service aboard tow boats in the brown waters in the Gulf of Mexico. The client did not want to re-design a new system due to the pumps not being made for the last 15 years by the manufacturer.*

Casing showing sings of extreme erosion from years of sandy water service.

The pumps were brought to the shop, de-salted, blasted to above a 3-mil average, rebuilt with 1311 and coated with two coats of 1331.

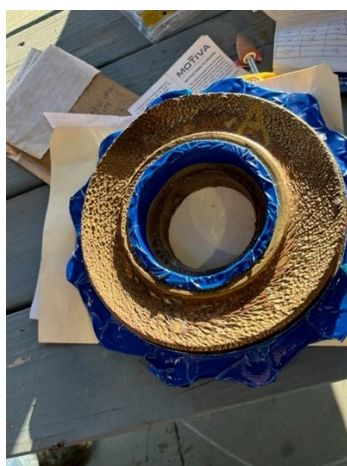
Backing Plate showing sings of extreme erosion from years of sandy water service.

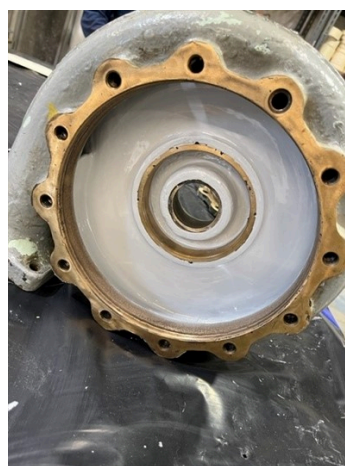
Freshly rebuilt and coated casing ready for more years of service.

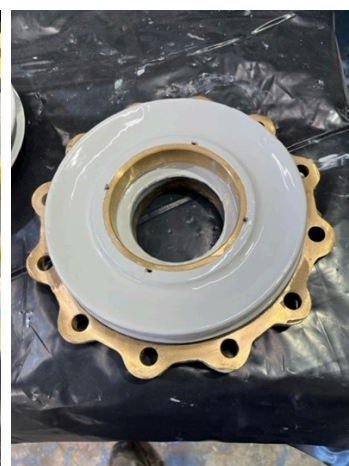
Backing plate feeling young again after being rebuilt and coated.
