# Belzona Beefs up Rock Box Wear Pad

ID: 9030

Industry: *Marine*  
Application: *SHM-Solids Handling Machinery*

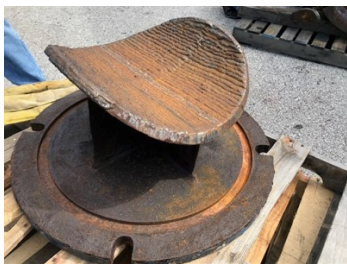
*Weld overlay wasnt enough for the wear pads of this dredging rock box. This wear pad will see anything from mud, sand, oysters, rocks, dropped tools in the bottom of the ship channel, and many other hard objects picked up by the dredging pump.*

Wear Plate Before

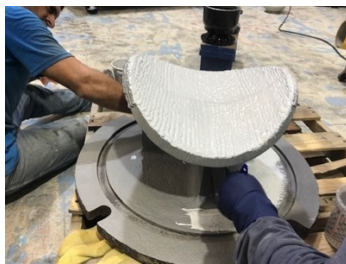
Priming coat of Belzona 1331

Blasted to SSPC-SP10 - minimum 3-mil anchor

Primer coat of Belzona 1331 to increase adhesion of the Belzona 1814

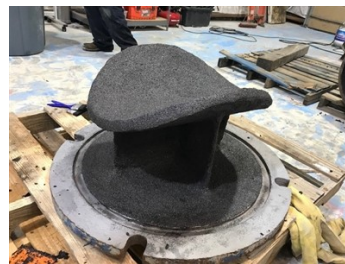
Finished coat of Belzona 1814

1/4" of Belzona 1814 applied to all wear surfaces
