Emergency Floor Repair with Belzona 4111

Application: FPA-Floor Problem Areas

Substrate: Concrete

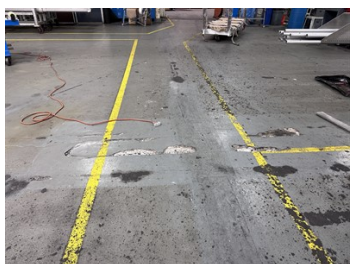
Designated walkway was heavily damaged over the years.

Previous repairs had failed and the client was faced with safety violations.

Traditional concrete was unable to withstand the chemicals and heavy traffic.

Area to be repaired

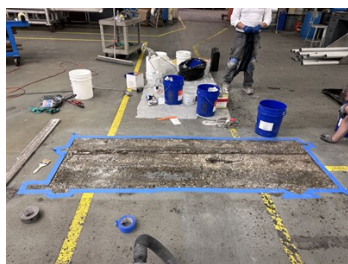
Repair area defined, sawcut and excavated
4911 Surface Conditioner Applied

Area was sawcut to a minimum of 0.25". Low spots were up to 3" deep and exposed rebar was prepped using a Bristle Blaster. A chipping hammer was used to remove break up the sections that were well adhered.

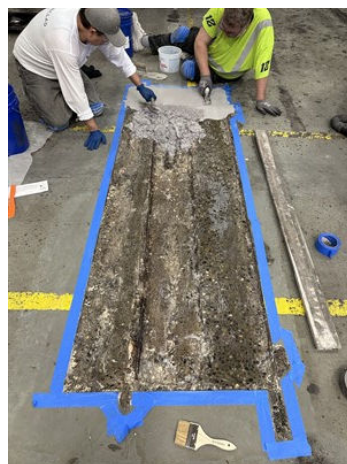
4111 Being Applied

Customer needed a quick turnaround to accommodate the next days shift. The floor was suffering from daily chemical contact that had worked through the previous coating and into the concrete. 4111 was selected for the quick turnaround and chemical resistance. The repair was completed with four and a half kits of 4111 in 3 hrs. No delays for the next days production.

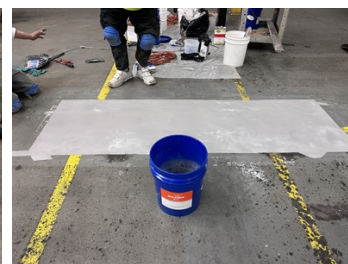
Finished Application
