BELZONA® 5851 HELPS AVOIDS SHUT DOWN

ID: 904

Customer Location: Production Rig North Sea
Application Date: May 2007

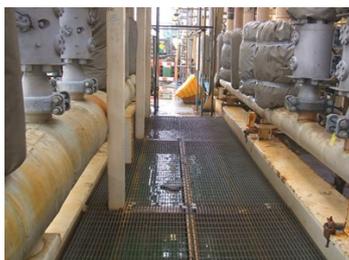
- * Manifold showing weathering of paintwork ,
- * Belzona® 5851 applied to exposed pipe work ,
- * Belzona® 5851 applied to exposed pipe work ,
- * Belzona® 5851 applied to the manifold ,

Weathering of the original paint system on high temperature Duplex lines.

Application carried out in accordance with modified Belzona System Leaflet VPF-2. The pipe- work was wet-blasted to remove poorly adhering paintwork and any salts from the substrate.
