BELZONA® 5851 HELPS AVOIDS SHUT DOWN

ID: 904

Customer Location: Production Rig North Sea
Application Date: May 2007

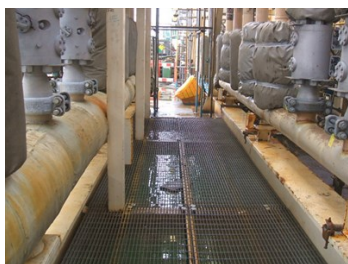
The loss of the original paint system exposed the pipe work to a risk of stress corrosion cracking whenever the fire protection Deluge system were tested.

- * Manifold showing weathering of paintwork ,
- * Belzona® 5851 applied to exposed pipe work ,
- * Belzona® 5851 applied to exposed pipe work ,
- * Belzona® 5851 applied to the manifold ,

Weathering of the original paint system on high temperature Duplex lines.

Application carried out in accordance with modified Belzona System Leaflet VPF-2. The pipe- work was wet-blasted to remove poorly adhering paintwork and any salts from the substrate.
