# Belzona 1341 Keeps Swimming Pool Running Smooth Year Round

ID: 9041

Industry: *Other* Customer Location: *Galveston, TX*  
Application: *CEP-Centrifugal Pumps* Application Date:  
Substrate: *Cast Iron*  
Products: *Belzona 1121 (Super XL-Metal), Belzona 1341 (Supermetalglide)*

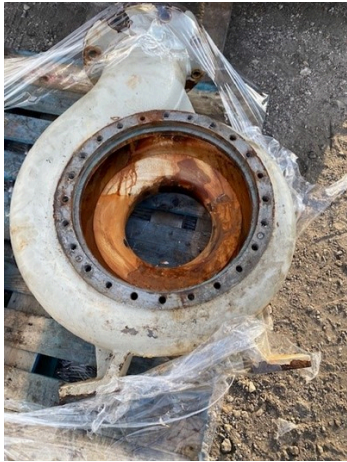
Casing before coating showing wear from service

This pool water pump had erosion and corrosion issues from years of service in a wave pool. The client was given a choice between repair or replacement and looked to Belzona for a replacement solution.

Pump was blasted to SP- 10

Rebuilt with 1121

2 coats of 1341

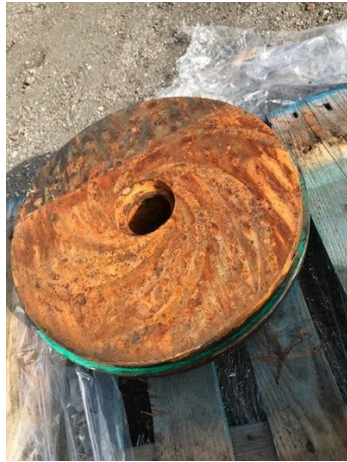
Pump plate before showing service wear

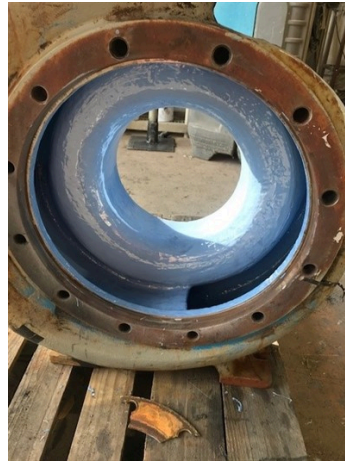
Freshly rebuilt and coated pump casing

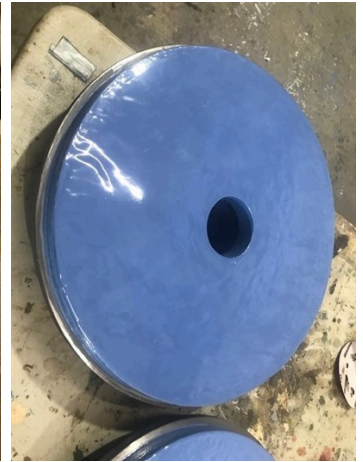
Super smooth rebuilt and coating of Belzona 1341 to the pump plate
