Belzona 1341 Keeps Swimming Pool Running Smooth Year Round

ID: 9041

Industry: *Other* Customer Location: *Galveston, TX*
Application: *CEP-Centrifugal Pumps* Application Date:
Substrate: *Cast Iron*
Products: *Belzona 1121 (Super XL-Metal), Belzona 1341 (Supermetalgilde)*

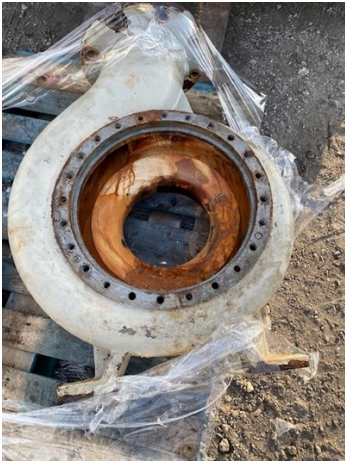
Casing before coating showing wear from service

This pool water pump had erosion and corrosion issues from years of service in a wave pool. The client was given a choice between repair or replacement and looked to Belzona for a replacement solution.

Pump was blasted to SP- 10

Rebuilt with 1121

2 coats of 1341
