Belzona 4311 CR1 protects bunds from chemical attack

Application: TCC-Tanks and Chemical Containment Areas

Substrate: Concrete

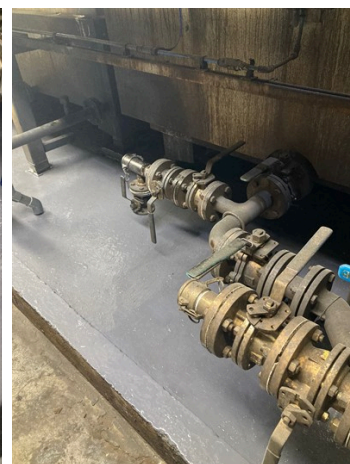
The system can be applied around complex geometry seamlessly

The systems were applied by brush to the required thickness. The metal vat legs were also coated to provide a seamless, leak free system
