Belzona 4311 CR1 protects bunds from chemical attack

ID: 9045

Application: TCC-Tanks and Chemical Containment Areas

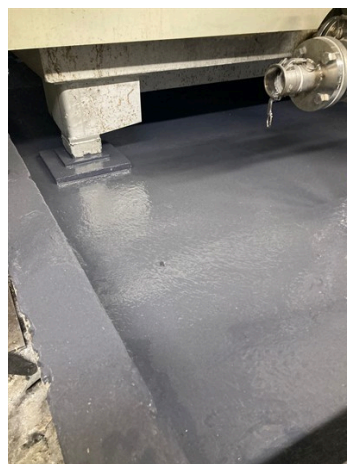
Belzona 4311 applied

The systems were applied by brush to the required thickness. The metal vat legs were also coated to provide a seamless, leak free system

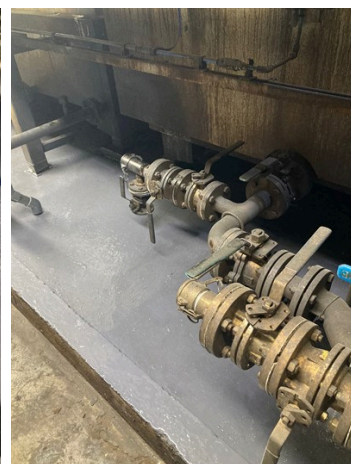
The system can be applied around complex geometry seamlessly
