Glass Lined Steel Shaft Repair

ID: 9046

Industry: Chemical & Petrochemical
Application: FBC-Fans, Blowers and Compressors

Substrate: Carbon steel
Products: Belzona 1511 (Super HT-Metal), Belzona 1593, Belzona 9111 (Cleaner Degreaser)

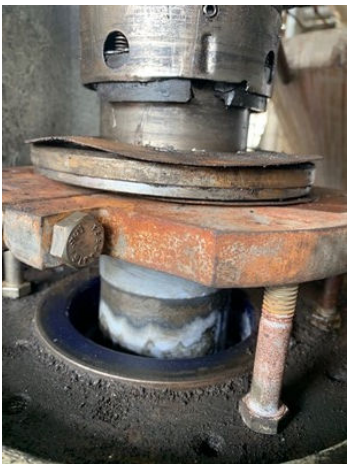
The customer had a glass lined carbon steel agitator that was inside of a reactor. The reactor contained Benzyl Chloride, Farmin DM2407N, A-95 and water. Maximum temperature was 300 deg F. As the agitator spun the bearing seal came loose, which caused the shaft to become damaged. The glass lined coating was removed and the carbon steel was gouged. The customer needed a quick efficient solution until the agitator could be replaced.

Close up on defect area of the shaft.

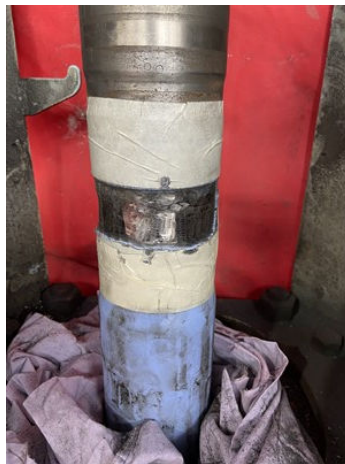
After surface preparation was completed on the defect area.

1. The repair area was not immersed. The shaft was out of service and was able to be repaired in place. Access was achieved by scaffold. The defect area was taped off.
2. We used a grinder with cutting disk to remove a minimum of 1/16" of metal and to roughen the surface. The area was then wiped clean with Belzona 9111 and allowed to dry.
3. Next, we mixed Belzona 1511 and scrubbed it into the profile to rebuild to the original shaft OD as best effort. An applicator was used to make the Belzona 1511 smooth.
4. Belzona 1593 was applied in one coat by brush to seal the damaged area.
5. The following day we came back to look for any pin holes or holidays in the coating, and none were found.

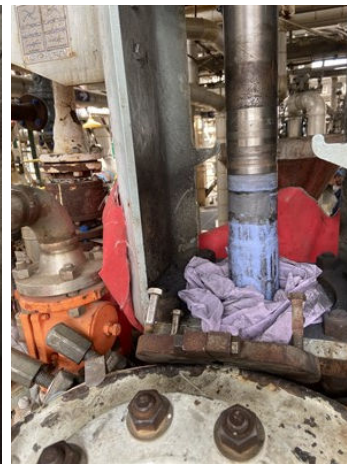
Shaft rebuilt with Belzona 1511 (high temperature paste grade system).

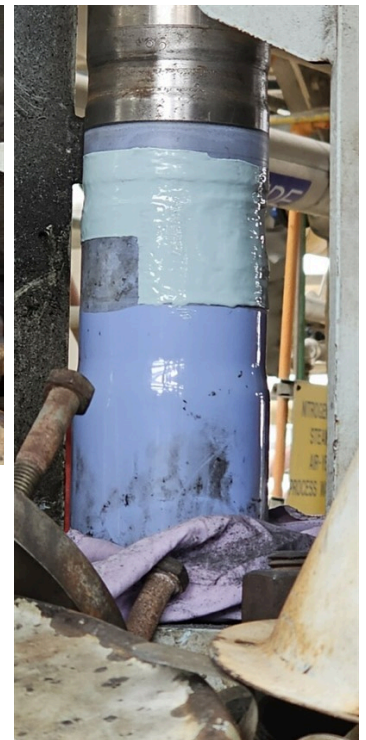
Belzona 1593 (high temperature coating) applied to seal the area.
