Glass Lined Steel Shaft Repair

ID: 9046

Industry: Chemical & Petrochemical
Application: FBC-Fans, Blowers and Compressors

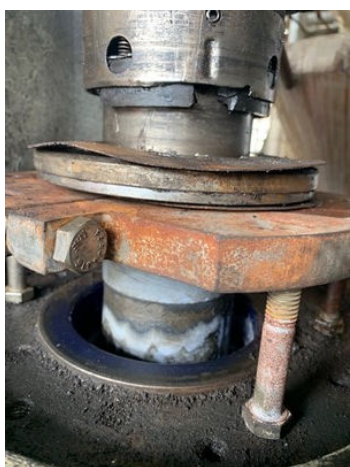
The customer had a glass lined carbon steel agitator that was inside of a reactor. The reactor contained Benzyl Chloride, Farmin DM2407N, A-95 and water. Maximum temperature was 300 deg F. As the agitator spun the bearing seal came loose, which caused the shaft to become damaged. The glass lined coating was removed and the carbon steel was gouged. The customer needed a quick efficient solution until the agitator could be replaced.

Close up on defect area of the shaft.

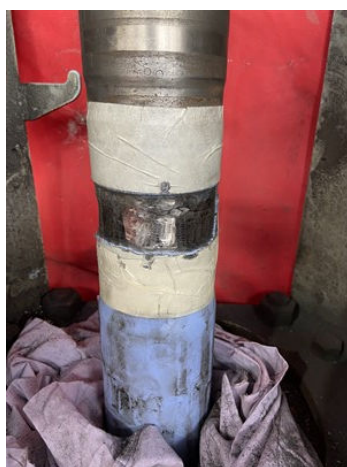
After surface preparation was completed on the defect area.

1. The repair area was not immersed. The shaft was out of service and was able to be repaired in place. Access was achieved by scaffold. The defect area was taped off.
2. We used a grinder with cutting disk to remove a minimum of 1/16" of metal and to roughen the surface. The area was then wiped clean with Belzona 9111 and allowed to dry.
3. Next, we mixed Belzona 1511 and scrubbed it into the profile to rebuild to the original shaft OD as best effort. An applicator was used to make the Belzona 1511 smooth.
4. Belzona 1593 was applied in one coat by brush to seal the damaged area.
5. The following day we came back to look for any pin holes or holidays in the coating, and none were found.

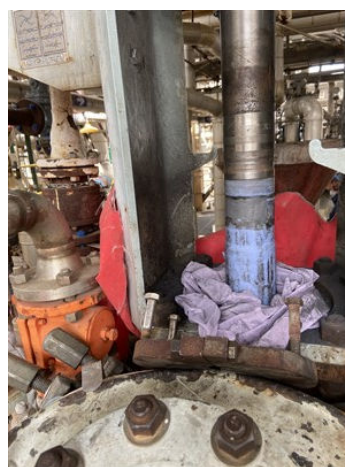
Shaft rebuilt with Belzona 1511 (high temperature paste grade system).

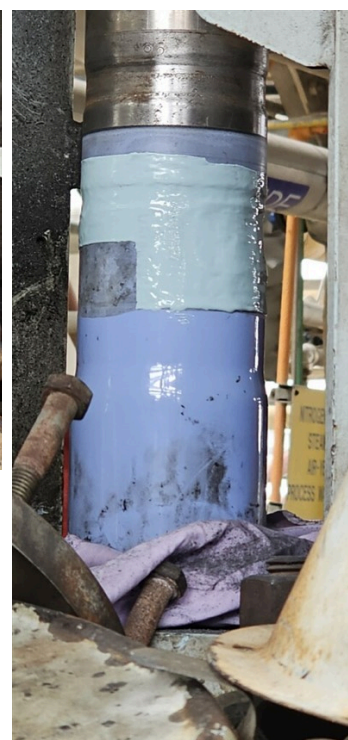
Belzona 1593 (high temperature coating) applied to seal the area.
