Rebuild and Protection of Discharge Elbows on a Francis Turbine

ID: 9047

Industry: Power

Application: VPF-Valves, Pipes and Fittings

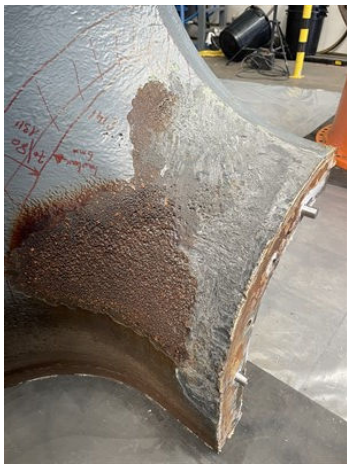
The discharge elbows of Francis turbines suffered severe cavitation-erosion in the inferior areas.

Damage caused by erosion-cavitation leading to a substrate loss greater than 5mm.

The areas affected by cavitation were reloaded using Belzona 1311. All elbows were then coated using Belzona 1331 or Belzona 1341. The most cavitation-intense zones were then further top coated using Belzona 2141 (an Anti-Cavitation Resistant Elastomer). The application was carried out in accordance with Belzona System Leaflet VPF-01 & VPF-02.

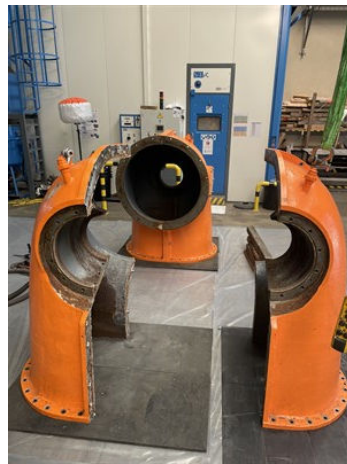
All elbows viewed together.

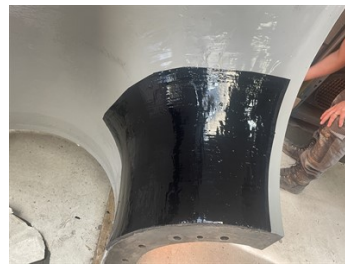
Post substrate rebuilding, the first coat of Belzona 1341 and Belzona 2141.

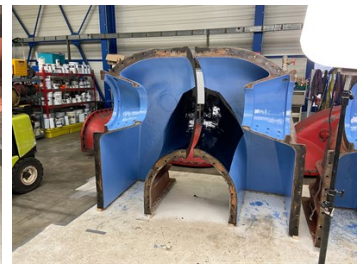
Final application showcasing Belzona 1431 and Belzona 2141.
