# Rebuild and Protection of Discharge Elbows on a Francis Turbine

ID: 9047

**Industry:** Power  
**Application:** VPF-Valves, Pipes and Fittings  
**Substrate:** Cast Iron  
**Products:** Belzona 1311 (Ceramic R-Metal), Belzona 1331, Belzona 1341 (Supermetalgilde), Belzona 2141 (ACR-Fluid Elastomer)

**Customer Location:** Hautes-Alpes  
**Application Date:** September 2022

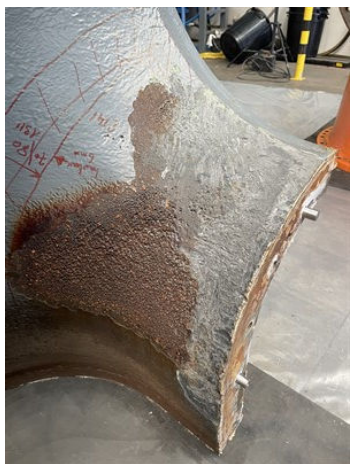
The discharge elbows of Francis turbines suffered severe cavitation-erosion in the inferior areas.

Damage caused by erosion-cavitation leading to a substrate loss greater than 5mm.

The areas affected by cavitation were reloaded using Belzona 1311. All elbows were then coated using Belzona 1331 or Belzona 1341. The most cavitation-intense zones were then further top coated using Belzona 2141 (an Anti-Cavitation Resistant Elastomer). The application was carried out in accordance with Belzona System Leaflet VPF-01 & VPF-02.

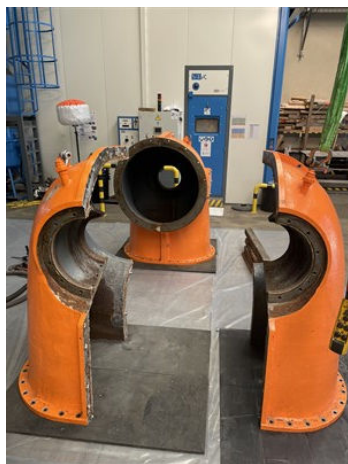
All elbows viewed together.

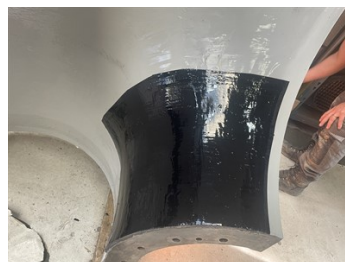
Post substrate rebuilding, the first coat of Belzona 1341 and Belzona 2141.

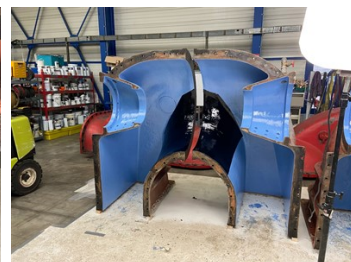
Final application showcasing Belzona 1341 and Belzona 2141.
