Pump Casing Internal Repair

ID: 9049

Application: CEP-Centrifugal Pumps

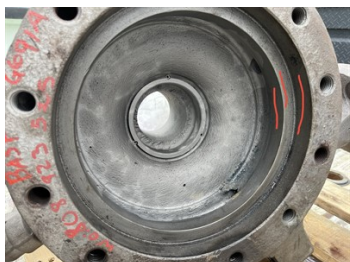
Customer had small through wall pin holes in the internals of a pump. Customer was facing a six month time before a new manufactured pump internal could be made and put into service. The issue may have been caused by corrosion or cavitation.

Pump internals after it was abrasive blasted. Two small holes shown.

Three small 1/8" size through wall holes.

1. We picked up the pump casing onsite of customer and brought it to our shop.
2. We complete surface preparation via vapor blasting, with emerald grit.
3. We patched the through wall defects by using Belzona 1511 and Belzona 9341 reinforcing mesh.
4. We applied a two coat system of Belzona 1593.

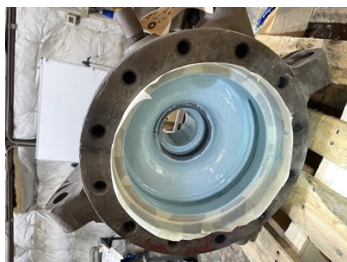
Pump internals were coated with Belzona 1593.

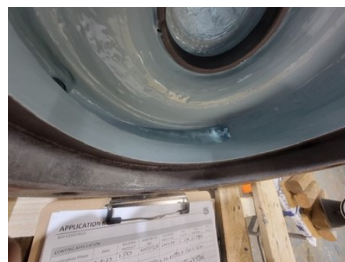
Close up on patched area with coating over top.

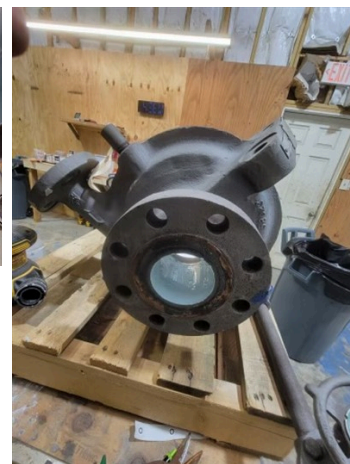
Back side view of completed project.
