Pump Casing Internal Repair

ID: 9049

Industry: Chemical & Petrochemical
Application: CEP-Centrifugal Pumps
Substrate: Carbon steel
Products: Belzona 1511 (Super HT-Metal), Belzona 1593, Belzona 9111 (Cleaner Degreaser)

Customer Location: Pasadena, TX, USA
Application Date: March 2023

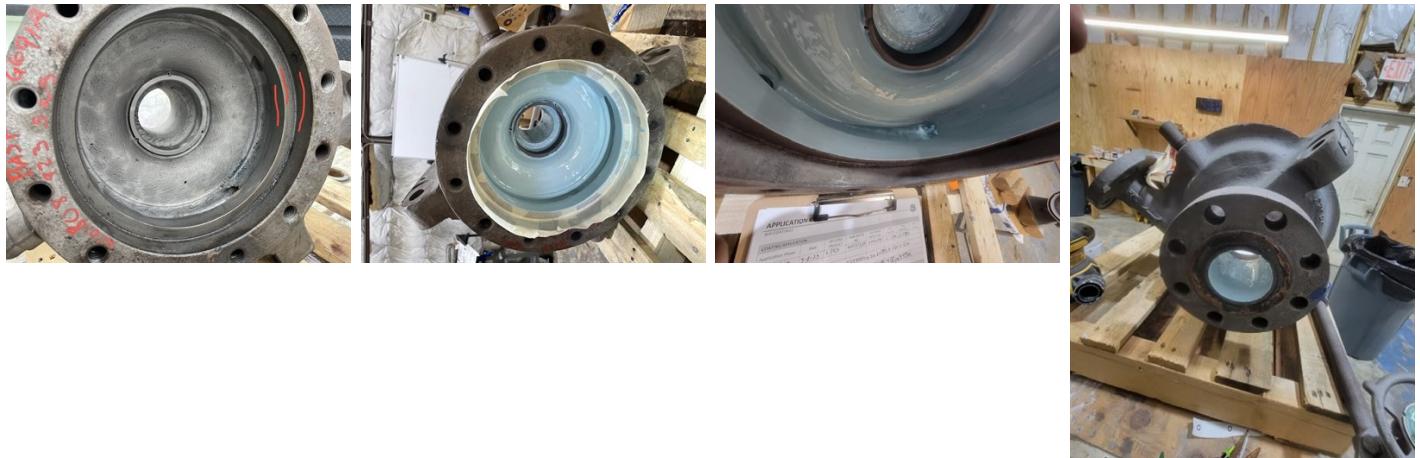
Customer had small through wall pin holes in the internals of a pump. Customer was facing a six month time before a new manufactured pump internal could be made and put into service. The issue may have been caused by corrosion or cavitation.

Pump internals after it was abrasive blasted. Two small holes shown.

Pump internals were coated with Belzona 1593.

Close up on patched area with coating over top.

Back side view of completed project.

Three small 1/8" size through wall holes.

1. We picked up the pump casing onsite of customer and brought it to our shop.
2. We complete surface preparation via vapor blasting, with emerald grit.
3. We patched the through wall defects by using Belzona 1511 and Belzona 9341 reinforcing mesh.
4. We applied a two coat system of Belzona 1593.
