BELZONA COATING OF BYRON JACKSON SHIPPER PUMP

ID: 905

Industry: Oil & Gas
Application: CEP-Centrifugal Pumps
Substrate: Cast Iron
Products: Belzona® 1311 (Ceramic R Metal)
Belzona® 1391 (Ceramic HT)

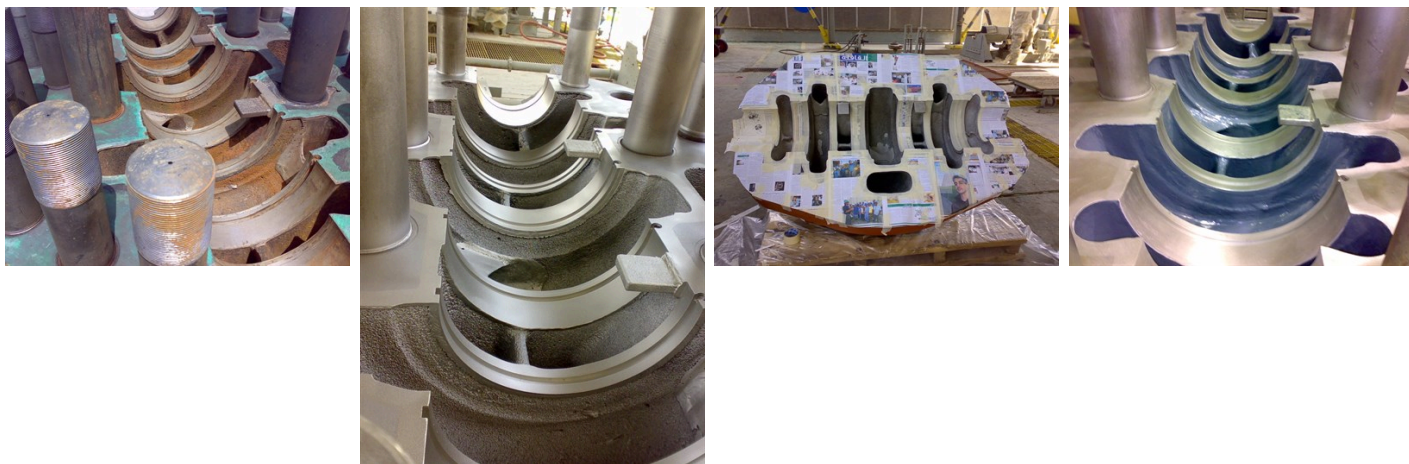
Photograph Descriptions

Erosion on the pump surface caused by sea water and sand inclusion during shipping operation.

* Before blasting , * After blasting with surface pitting evident , * Rebuilding with Belzona® 1311 , * Finished application with Belzona® 1391 ,

Erosion on surfaces of multi-stage pump.

Application was carried out in accordance with the Belzona Know-How System Leaflet CEP-3 & 5
