Belzona Repairs two Hydrocyclones within a Sugar Refinery using Alumina Tiles.

ID: 9051

Application: VPF-Valves, Pipes and Fittings

Application Date: February 2023

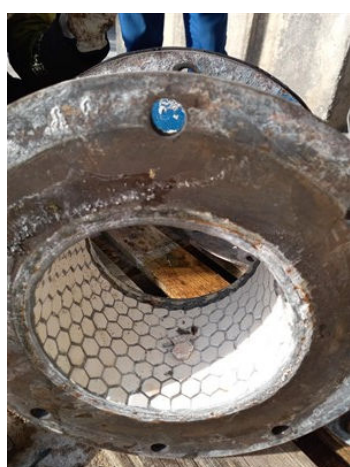
Two hydrocyclones were subjected to strong abrasion combined with a chemical attack (Milk of Lime; $[Ca(OH)_2]$). After 6-years of operation, a refurbishment was necessary.

Current system after 6-years of service.

The substrate was first prepared, followed by bonding the Belzona 9811 alumina tiles using Belzona 1391 (remaining stock). Once the tiles were glued in place, the interstices were grouted using Belzona 1814. The application was carried out in accordance with Belzona System Leaflet VPF-02.

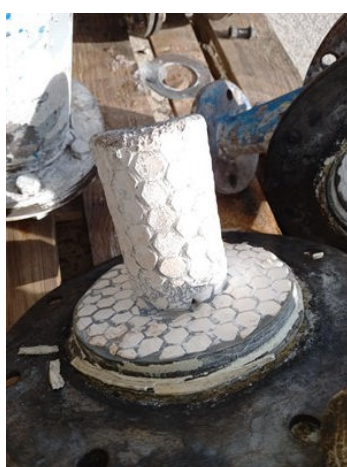
Current system after 6-years of service.

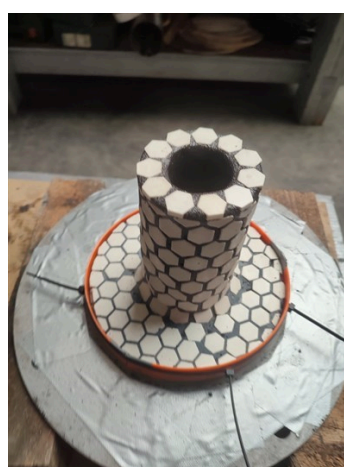
During the repair procedure.
