Belzona 5721 Repairs Cooling Tower Fan Blades Leading Edge

ID: 9055

Industry: Power
Application: FBC-Fans, Blowers and Compressors

Customer Location: Wilsonville, AL
Application Date: April 2023

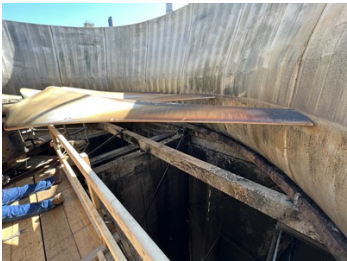
The customer had some questionable fan blades that were in need of attention. The leading edge has some light pitting and deteriorated from erosion and wear. They were looking to protect the current ones in service rather than purchasing new ones.

Before - In Service Pitted Blades
Before - Close up of Current Condition pitting/wear on the leading edge

After pressure washing, we addressed any small pits along the leading edge and sanded down the area to coat a 4" strip of Belzona 5721 (designed for wind turbine blades) that ran the edge of the 11' blade.
