Belzona 5721 Repairs Cooling Tower Fan Blades Leading Edge

ID: 9055

Industry: Power
Application: FBC-Fans, Blowers and Compressors

Customer Location: Wilsonville, AL
Application Date: April 2023

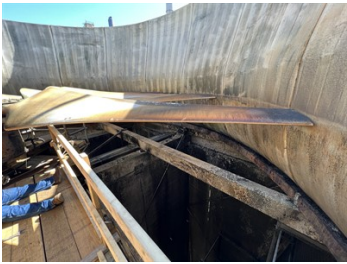
The customer had some questionable fan blades that were in need of attention. The leading edge has some light pitting and deteriorated from erosion and wear. They were looking to protect the current ones in service rather than purchasing new ones.

Before - In Service Pitted Blades
Before - Close up of Current Condition pitting/wear on the leading edge

After pressure washing, we addressed any small pits along the leading edge and sanded down the area to coat a 4" strip of Belzona 5721 (designed for wind turbine blades) that ran the edge of the 11' blade.

- Use sander for profile.
- Apply Belzona 2911 QD conditioner let cure.
- Apply 1st coat Belzona 5721 UV stable coating white let cure.
- Apply 2nd coat Belzona 5721 UV stable coating grey let cure.
- Blades to be wrapped in bubble wrap to protect leading edge for transport to facility.

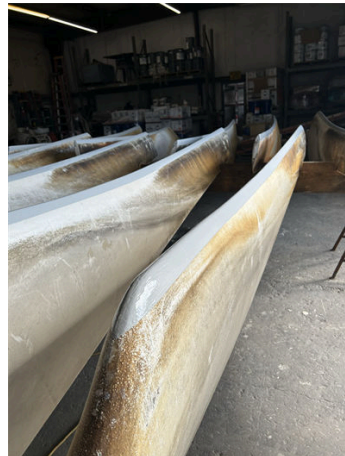
Completed View 1 4" Strip of Belzona 5721 Applied to Leading Edge

Coated leading edge 2" on both sides of blades.

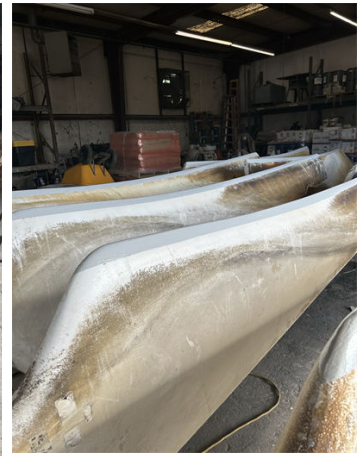
Completed View 2 - 4" Strip of Belzona 5721 Applied to Leading Edge
