# BELZONA REBUILDS WEAR RING SEATS

ID: 906

Industry: Power  
Application: CEP-Centrifugal Pumps  
Substrate: Cast Iron  
Products: Belzona® 1311 (Ceramic R-Metal)

Customer Location: Power plant - Tulsa, Oklahoma, USA  
Application Date: October 2007

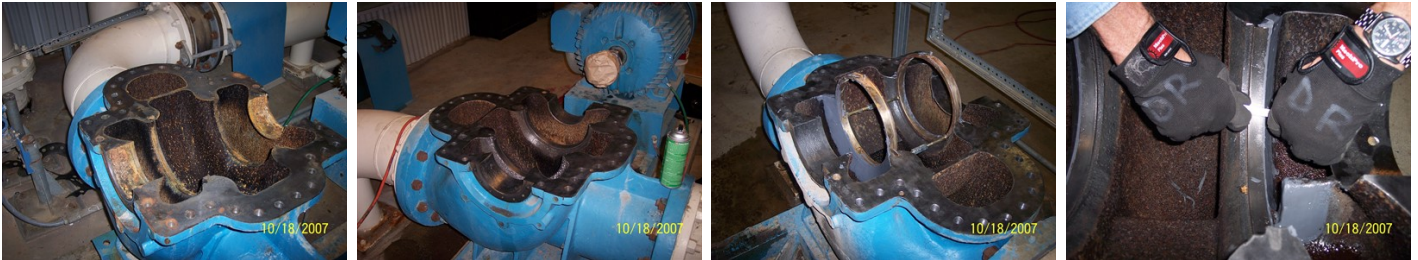
**Problem**  
Severe erosion corrosion

\* Pump to be rebuilt , \* Surface being prepared , \* Wear rings used as formers for Belzona® 1311 rebuild , \* Scrapers used to complete application ,

Auxiliary pump casing

Application carried out in accordance with Belzona System Leaflet CEP-2. Wear rings used as formers. After curing excess Belzona® 1311 removed with scrapers.

Belzona repair carried out quickly, postponed pump replacement, and improved pump efficiency.
