Belzona protects cooling water pump's impeller from cavitation in nuclear power plant

Application: CEP-Centrifugal Pumps

Substrate: Stainless-steel

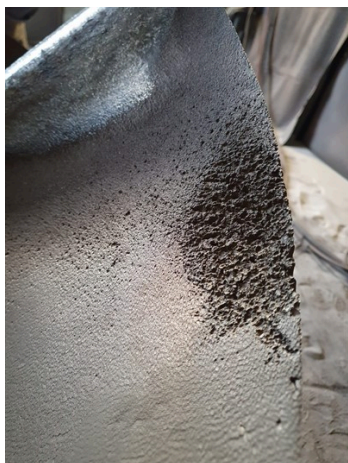
At the end of planned overhaul, severe cavitation was detected on one of the main cooling pumps.

Cavitation damage

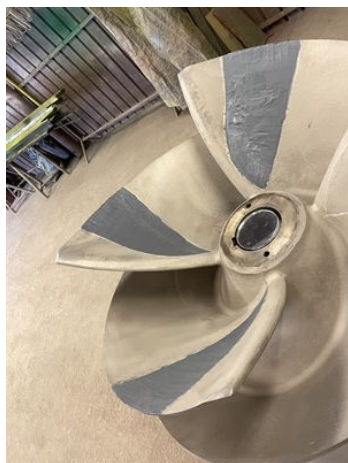
Rebuilding the damaged surface

Cavitation damage was rebuilt to profile with Belzona 1111.

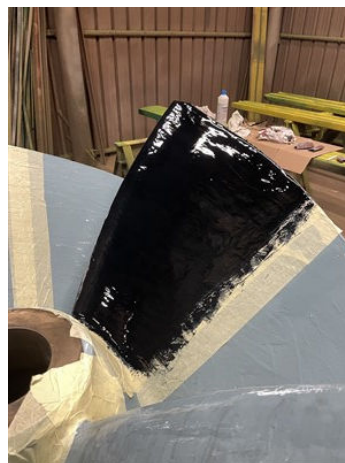
Coating the surface

Whole surface was protected with efficiency enhancement protective coating Belzona 1341.

Cavitation impact zones were coated with Belzona 2141 elastomer that can withstand cavitation.

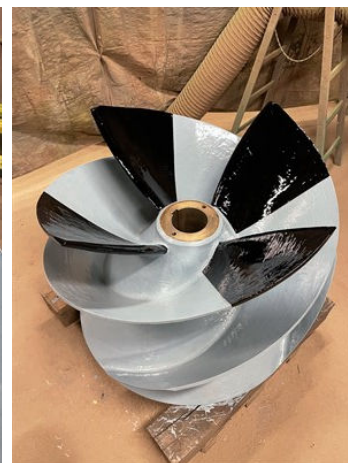
Finished application
