# Belzona protects cooling water pump's impeller from cavitation in nuclear power plant

ID: 9060

Customer Location: *Krško*

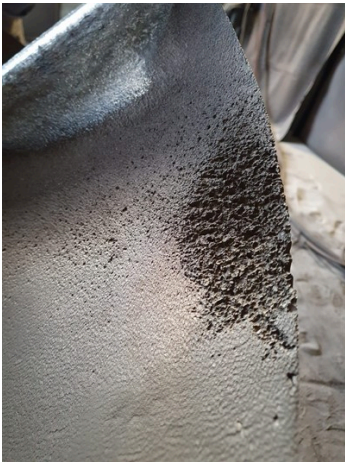
*At the end of planed overhaul, severe cavitation was detected on one of the main cooling pumps.*

Cavitation damage

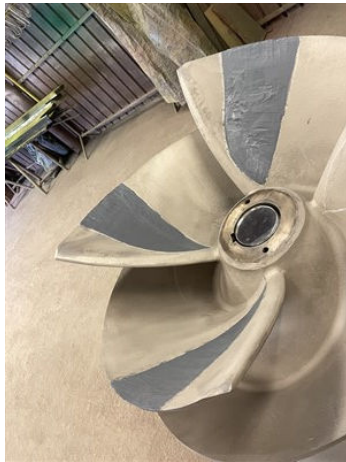
Rebuilding the damaged surface

The pump's impeller was grit blasted according to standard stated in the instructions for use.

Cavitation damage was rebuilt to profile with Belzona 1111.

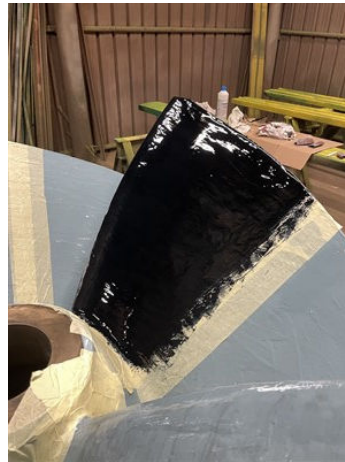
Coating the surface

Whole surface was protected with efficiency enhancement protective coating Belzona 1341.

Cavitation impact zones were coated with Belzona 2141 elastomer that can withstand cavitation.

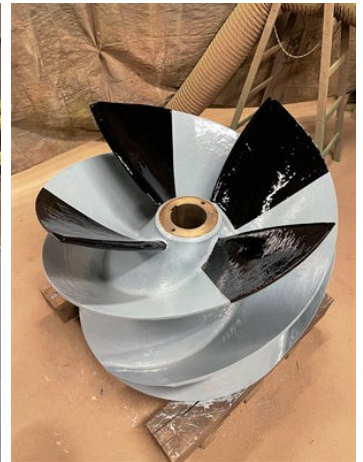
Finished application

Belzona distributor stepped up with a cost effective solution that would rebuild and protect the pump from further cavitation while providing efficiency enhancement to the pumps impeller. The repair and protection was completed in 4 days.
