# Belzona protects cooling water pump's impeller from cavitation in nuclear power plant

ID: 9060

Industry: Power  
Application: CEP-Centrifugal Pumps  
Substrate: Stainless-steel  
Products: Belzona 1111 (Super Metal), Belzona 1341 (Supermetalglide), Belzona 2141 (ACR-Fluid Elastomer)

Customer Location: Krško  
Application Date:

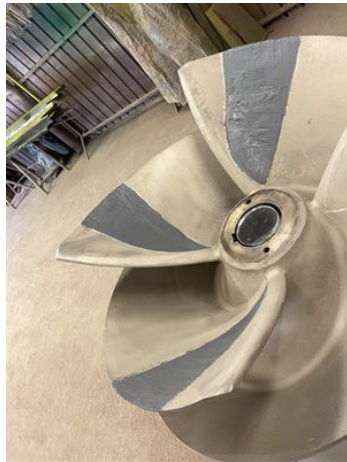
Rebuilding the damaged surface

Cavitation damage was rebuilt to profile with Belzona 1111.
