# Debarker Ring protection saving lumber mill thousands

ID: 9063

Customer Location: Vancouver Island, British Columbia

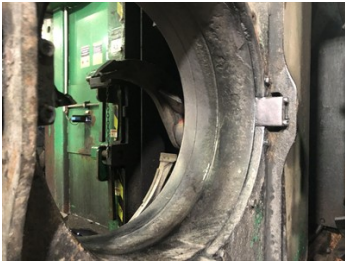
Corrosion was occurring from the salt water that enters the lumber mill from the ocean. This jeopardizes the bearing inside the ring that has a replacement cost of \$35,000.00. Protection was needing to prolong the service life of the machinery

Condition of Debarker ring

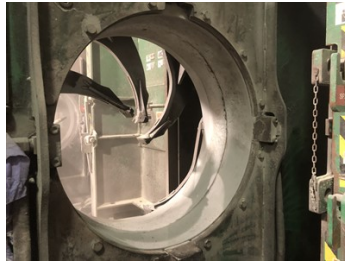
After sandblasting

Initial sandblasting was required for sufficient surface preparation. All Belzona material were mixed applied by hand to specification. Heat was added to assist in the curing process. The customer was thrilled with the result.

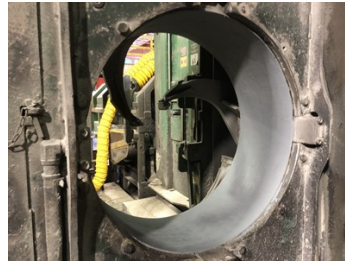
Resurfacing with Belzona 1311

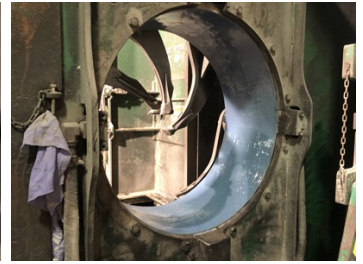
Coating of Belzona 1321
