Belzona seals the expansion joint at the entrance to the underground garage of a large residential building

ID: 9066

Application: FPA-Floor Problem Areas

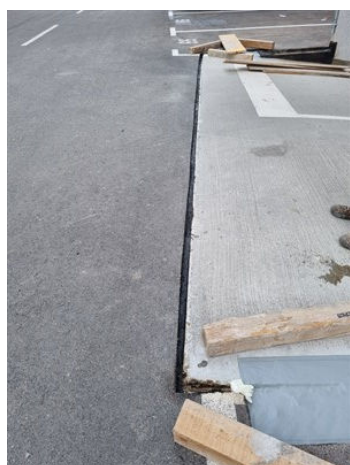
Expansion joint cleaned and conditioned with Belzona 4911

We grinded away asphalt and concrete until we reached the existing insulation beneath them. Then we thoroughly cleaned the surface and applied Belzona 4911 Conditioner. Right after that, we applied Belzona 4511 on both sides (downward slopes) and Belzona 4521 on the horizontal section. Then we protected the area of application with thick planks, so tenants could use the underground garage.
