# Belzona Unclogs Fouled Scrubber

Industry: Sugar  
Application: TCC-Tanks and Chemical Containment Areas  
Substrate: Carbon steel  
Products: \* Belzona® 1811 (Ceramic Carbide) ,  
\* Belzona® 1391 (Ceramic HT) ,

Customer Location: Sugar Refinery - Florida USA  
Application Date: October 2005

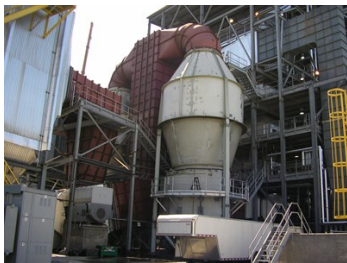
Carbon steel vessel walls had become rough due to corrosion. Roughened walls then trapped sand and ash which lead to rapid fouling four to eight feet thick. This fouling rendered the scrubber ineffective and the electrostatic precipitator had to make up the deficit at a cost of \$50,000 per day.

- \* One of two scrubbers to be rescued with Belzona. ,
- \* Belzona® 1811 (Ceramic Carbide) was applied to high wear areas to provide extra abrasion resistance. ,
- \* Belzona® 1391 (Ceramic HT) provides a smooth surface and has the abrasion and temperature resistance required. ,
- \* Belzona® 1391 (Ceramic HT) eleven months later. Discoloration is caused by elevated temperatures but coating is 100% intact and fouling was totally eliminated. ,

Belzona® 1811 and Belzona® 1391 were applied in accordance with a modified Belzona Know-How System Leaflet TCC-3.
