Belzona Patches Heated Oil Jacket

ID: 9074

Industry: Chemical & Petrochemical
Application: TCC-Tanks and Chemical Containment Areas

Customer Location: Shreveport, LA
Application Date: May 2023

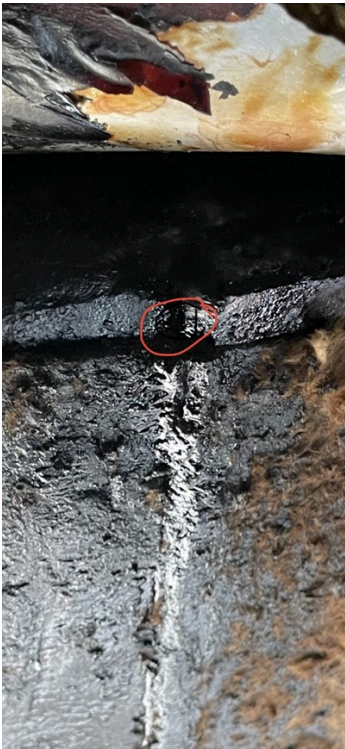
Customer had a pinhole leak in corner of heated oil jacket. It was not possible to drain this jacket as it was tied into the other 73 tanks.

Pinhole leak in oil jacket

Belzona 9611 was used to plug the hole with Belzona 1221 used as reinforcement. Once that was cured and leak was stopped, Belzona 1511/9341 was used to create a patch over the top of the leak for rebuild/reinforcement.

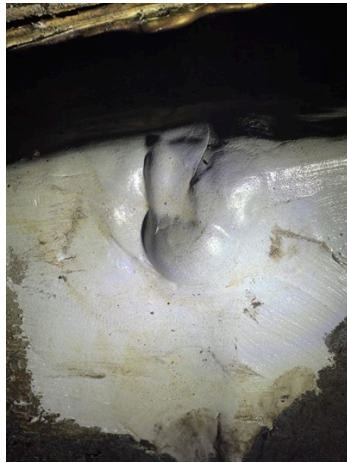
Live leak plugged with Belzona 1221

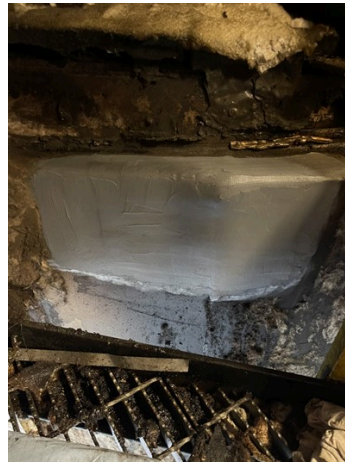
Belzona 1511 used to rebuild the area
