# Leak Repair at Pickling Line

**Industry:** Steel & Metal Processing  
**Application:** TCC-Tanks and Chemical Containment Areas  
**Substrate:** Carbon steel  
**Products:** Belzona 1511 (Super HT-Metal), Belzona 1593, Belzona 9111 (Cleaner Degreaser)

**Customer Location:** Nanticoke, Ontario  
**Application Date:** November 2017

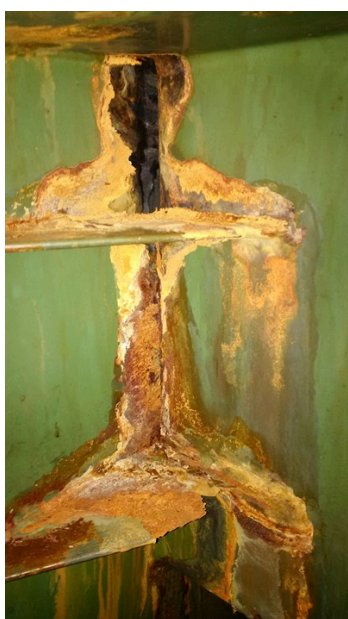
Hydrochloric acid tank in a Pickle line was suffering from chemical attack and developed a leak. They needed a product that had excellent chemical resistance against Hydrochloric acid at high concentrations to stop this leak and protect the outside of the tank.

The substrate chemically attacked from the acid

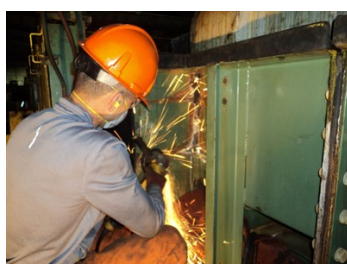
Surface preparation with a grinder to bare metal

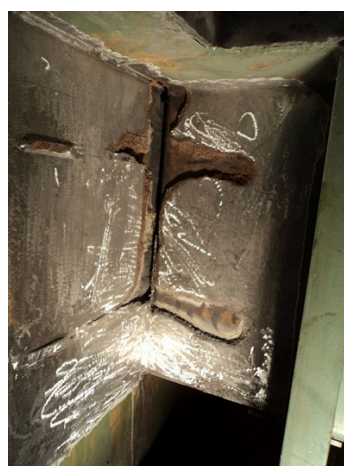
Cleaned substrate before product application

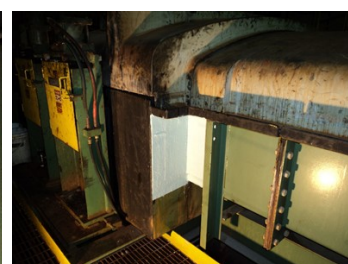
Finished application with Belzona 1593 as top coat

Belzona 1511 was used to bond the plate securely along its perimeter, while Belzona 1593 was injected to fill the void and ensure optimal protection against the chemical exposure. To provide comprehensive protection, the top of the plate and its surrounding

areas were coated with a layer of Belzona 1593, further enhancing the durability and longevity of the repair.
