Belzona Forms Gasket Surface on over 50 year old Boiler

ID: 9081

Application: GSS-Gaskets, Seals and Shims

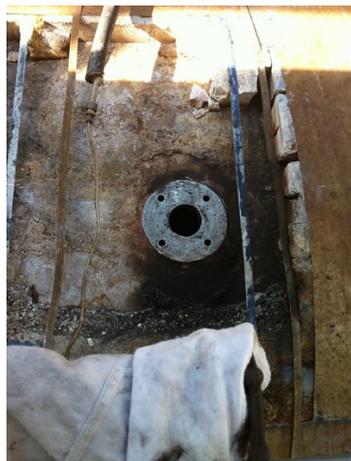
The gasket surface on the nozzle of a boiler was heavily pitted not allowing them to achieve a seal.

Gasket damage

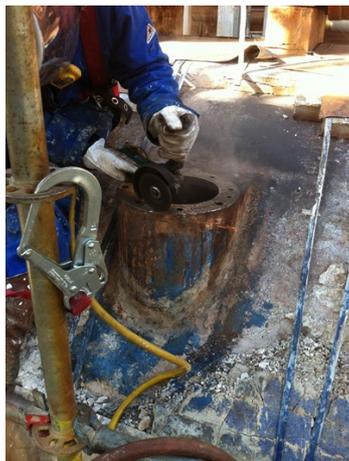
Surfaces preparation

Hand tools were used for preparation of the surface. Belzona Release Agent was applied to the former to allow removal.

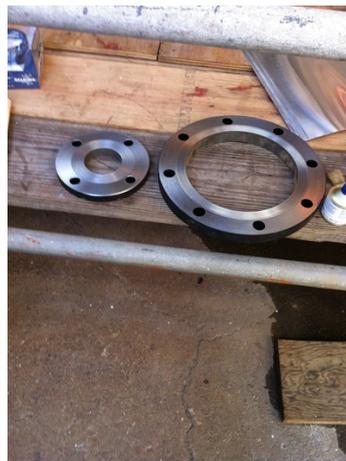
Formers used

Belzona 1111 was used in conjunction with a former to restore the gasket surface to the boiler nozzle.

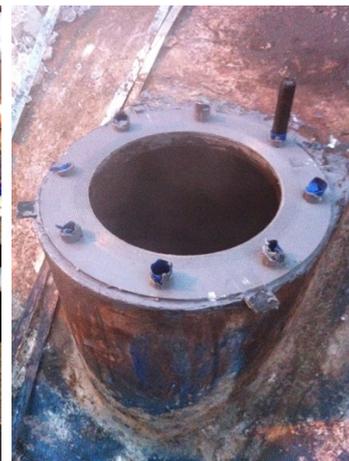
Application completed
