# Belzona Forms Gasket Surface on over 50 year old Boiler

ID: 9081

Application: GSS-Gaskets, Seals and Shims

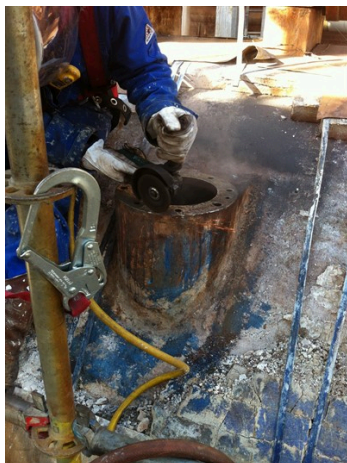
Surfaces preparation

Hand tools were used for preparation of the surface. Belzona Release Agent was applied to the former to allow removal.

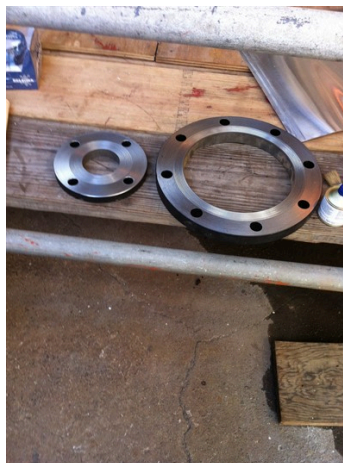
Formers used

Belzona 1111 was used in conjunction with a former to restore the gasket surface to the boiler nozzle.

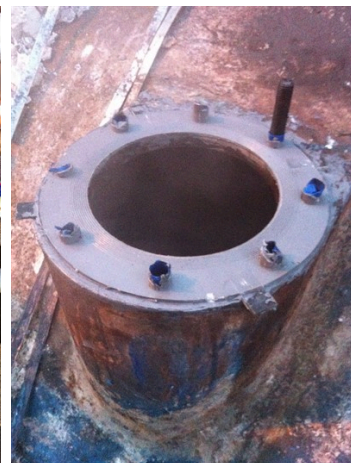
Application completed
