Belzona Protects Acid Barge Drip Pans

ID: 9082

Application: *TCC-Tanks and Chemical Containment Areas*

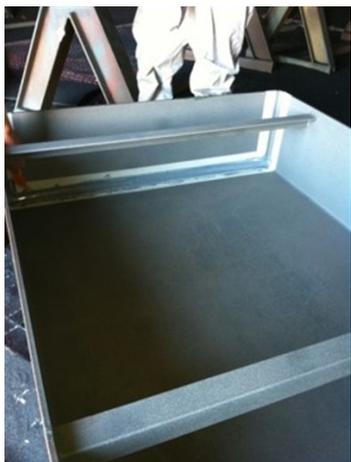
Customer was experiencing corrosion in their unlined drip pans.

Surface preparation drip pan 1

Client was replacing their acid drip pans every few years. Acid remnants would sit in the pans exposed to atmosphere and corrode the bottom.

Grit basted the interior surface. Applied 4301 to fillet the weld seams. Then applied 4311 to the entire interior.

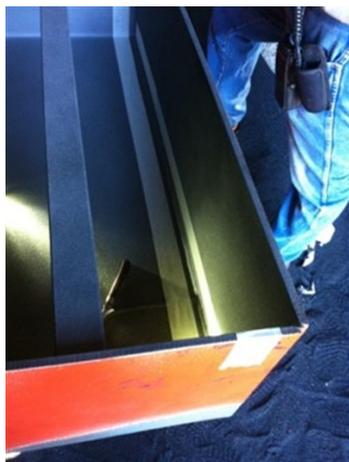
Surface preparation drip pan 2

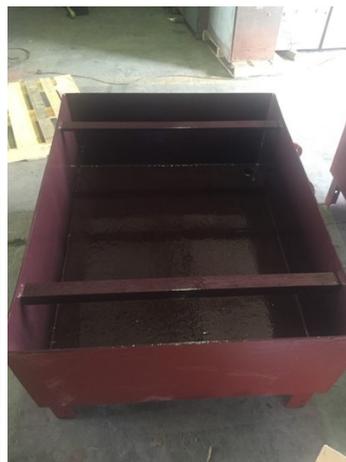
Product application process

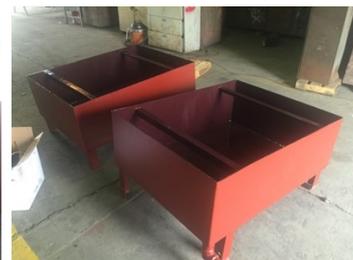
Application completed.

Coating with Belzona dramatically extended the life of the pans, saving the customer money not having to replace them every few years.
