Belzona Repairs Damaged Floor in Sterile Cartwashing Area in Local Hospital

Application: FPA-Floor Problem Areas

Substrate: Concrete

Customer Location: High Point, North Carolina

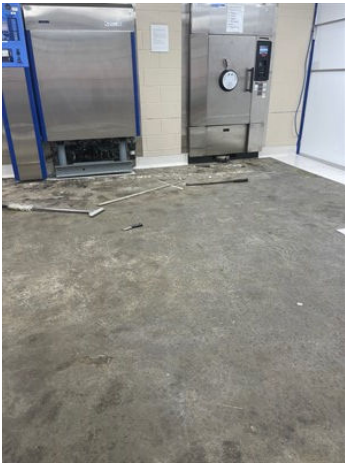
Vinyl Flooring Removed
