# Belzona Repairs Damaged Floor in Sterile Cartwashing Area in Local Hospital

Industry: Buildings & Structures  
Application: FPA-Floor Problem Areas  
Substrate: Concrete  
Products: Belzona 1121 (Super XL-Metal), Belzona 1321 (Ceramic S-Metal), Belzona 4311 (Magma CR1), Belzona 4911 (Magma TX Conditioner)

Customer Location: High Point, North Carolina  
Application Date: April 2023

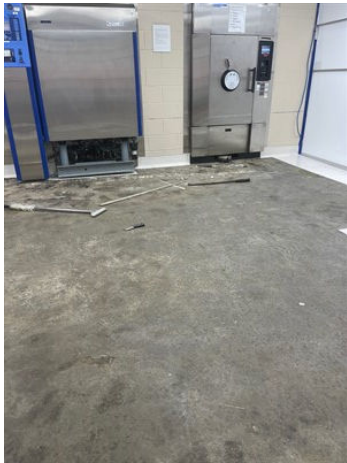
Vinyl Flooring Removed

Arrived at hospital Saturday morning at 8 aM. We taped off and cut out existing vinyl flooring. We then grinded entire floor with Hepa filter concrete grinder. After cleaning the floor we repaired uneven areas with Belzona 1121. We taped off Cart entrances and applied two coats of Belzona 1321. Came back Sunday morning and taped off rest of area, applied one coat Belzona 4911, and applied two coats of Belzona 4311. Application finished at 12 noon and Hospital crew came in later in evening to reassemble the room. Area put back to use Monday morning.

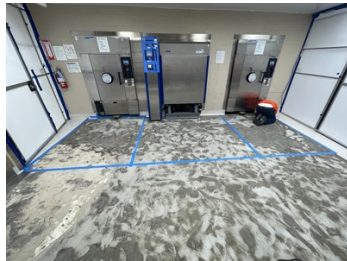
Floor area grinded

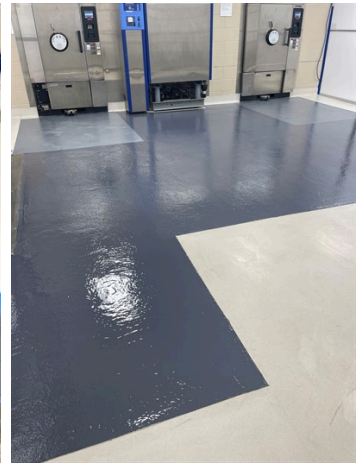
Belzona 4311 applied to rest of the area
