# Belzona Repairs Leaking Elevator Pit at Apartment Complex

ID: 9110

**Industry:** Buildings & Structures  
**Application:** FPA-Floor Problem Areas  
**Substrate:** Concrete  
**Products:** Belzona 4111 (Magma-Quartz), Belzona 4911 (Magma TX Conditioner), Belzona 5811 (Immersion Grade)

**Customer Location:** Greensboro North Carolina  
**Application Date:** March 2022

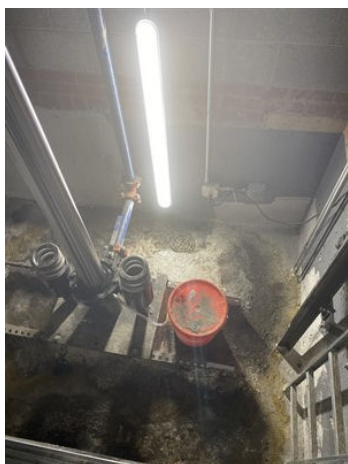
Elevator Pit was leaking really bad from around the shaft area and from under a metal plate. The pit was not passing inspection by the state of North Carolina and was going to be shut down and taken out of service. It was the only elevator in a 4 story apartment building.

Elevator Pit

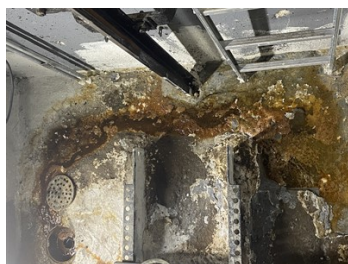
Visual Damage

We cleaned the surface and grinded out all the old repair material. We discovered the leaking area and applied a vacuum to the area to maintain a dry surface. Application of Belzona 4111 to entire area on and around the metal shaft plate. Coating of Belzona 5811 applied to entire area including the walls.

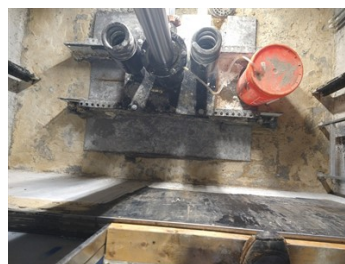
Application in progress

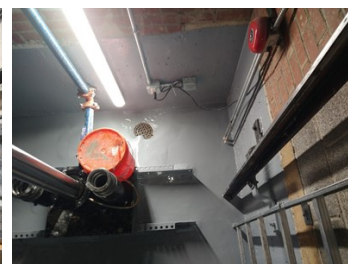
Complete application
