# Belzona Repairs Leaking Elevator Pit at Apartment Complex

ID: 9110

Application: FPA-Floor Problem Areas

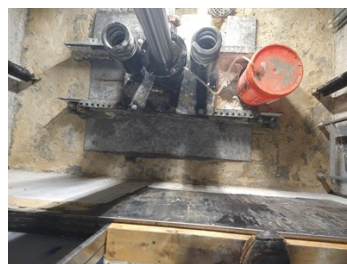
Application in progress

We cleaned the surface and grinded out all the old repair material. We discovered the leaking area and applied a vacuum to the area to maintain a dry surface. Application of Belzona 4111 to entire area on and around the metal shaft plate. Coating of Belzona 5811 applied to entire area including the walls.

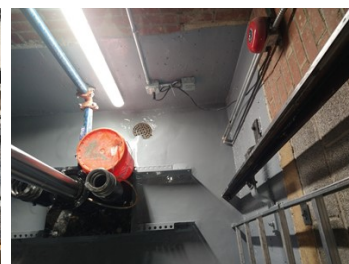
Complete application
