Belzona Repairs Leaking Elevator Pit at Apartment Complex

ID: 9110

Customer Location: Greensboro North Carolina

Application: FPA-Floor Problem Areas

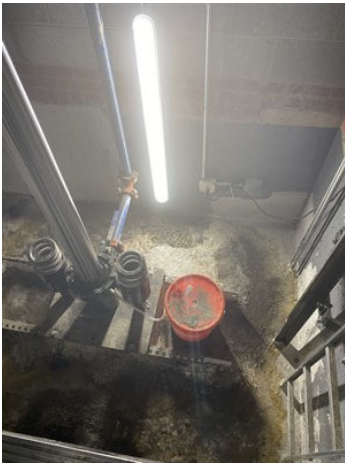
Elevator Pit was leaking really bad from around the shaft area and from under a metal plate. The pit was not passing inspection by the state of North Carolina and was going to be shut down and taken out of service. It was the only elevator in a 4 story apartment building.

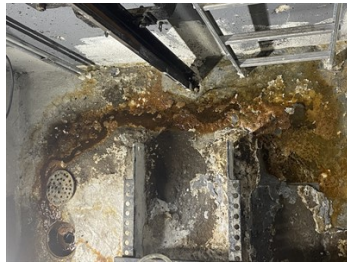
Visual Damage

We cleaned the surface and grinded out all the old repair material. We discovered the leaking area and applied a vacuum to the area to maintain a dry surface. Application of Belzona 4111 to entire area on and around the metal shaft plate. Coating of Belzona 5811 applied to entire area including the walls.

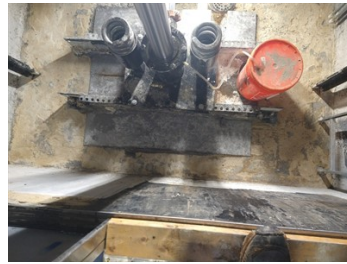
Application in progress

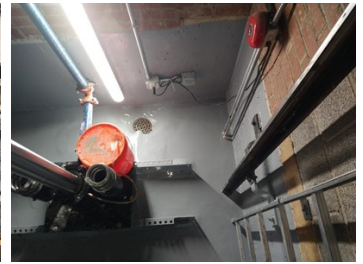
Complete application
