Belzona 1818 Protects Shaft from Abrasion

ID: 9114

Industry: *Cement*
 Application: *SHM-Solids Handling Machinery*

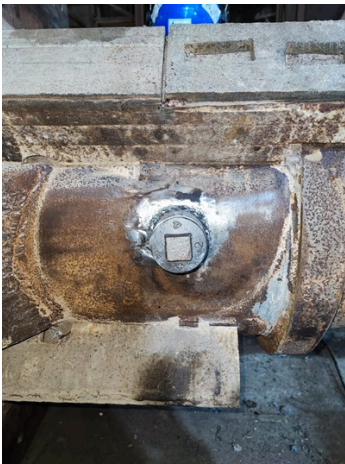
Area prepared using a power tool (MBX Bristle Blaster)

The areas where Belzona 1818 was to be applied were prepared using an MBX Bristle Blaster.

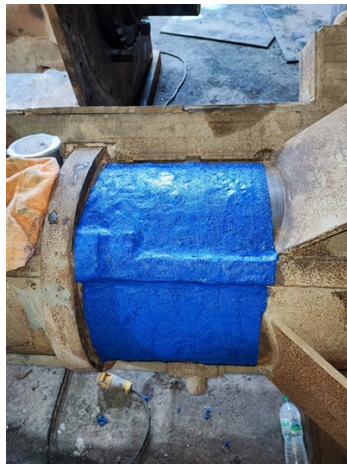
Belzona 1818 applied

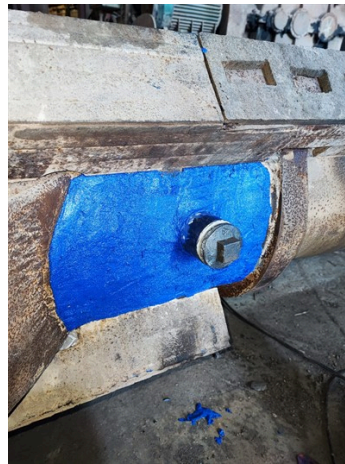
Belzona 1818 applied

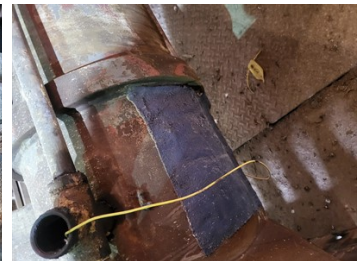
Belzona 1818 after 15 months in service
