Belzona 1818 Protects Shaft from Abrasion

Industry: Cement

Application: SHM-Solids Handling Machinery

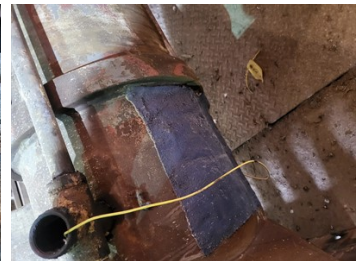
Belzona 1818 after 15 months in service
