# REPAIR, REBUILDING AND PROTECTION OF IMPELLER IMPELLER WITH BELZONA TECHNOLOGY

ID: 9132

Industry: Food & Drink  
Application: CEP-Centrifugal Pumps  
Substrate: Cast Iron  
Products: Belzona 1311 (Ceramic R-Metal), Belzona 1391T

Customer Location: SANTA CRUZ, BOLIVIA

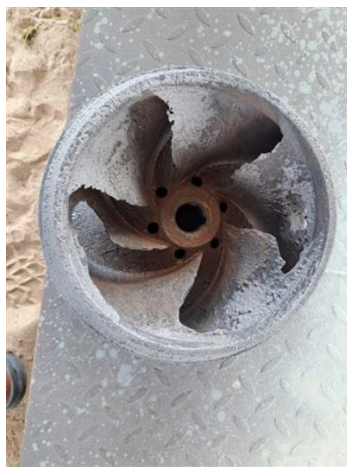
Sandblasted Impeller.

- Surface preparation with abrasive pressure blasting according to SSPC SP10, using sand as abrasive.
- Immersion of the Super Fox to completely remove the rust on the impeller surface.
- Rinsing with demineralized water.
- Degreasing of the surface with ethyl acetate.
- Measurement of environmental conditions prior to application.
- Measurement of reinforcement mesh to recover lost metal on blades.
- Recovery of lost metal with Belzona 1311 Ceramic R-Metal cold welding.
- Application of Belzona 1391T first layer coating
- Belzona 1391T second layer coating application
