BELZONA PROTECTS CONTAINMENT AREA

ID: 914

Industry: Power
Application: TCC-Tanks and Chemical Containment Areas
Substrate: Concrete
Products: Belzona® 4111 (Magma Quartz)
Belzona® 4311 (Magma CR1)

Customer Location: Power Project - Bastrop, Texas, USA
Application Date: November 2007

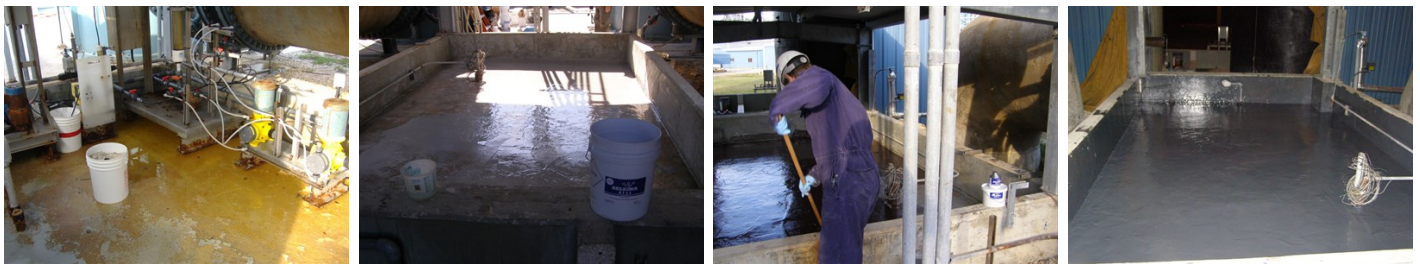
Photograph Descriptions

The previous coating had failed causing significant damage to the underlying concrete.

* Containment area prior to being coated , * Area prepared and leveled with Belzona® 4111 , * First coat of Belzona® 4311 being applied , * Completed application ,

The application was carried out in accordance with Belzona System Leaflets TCC-9 & 15

Previous attempts to coat this area had failed due to the chemical concentration. Belzona was chosen for its high chemical resistance. The two color system was also seen as an advantage as it will show when the coating needs to be touched up.
