# BELZONA RELIEF VALVE REPAIR

ID: 915

Customer Location: Hydro Electric Generating Station -  
Scotland

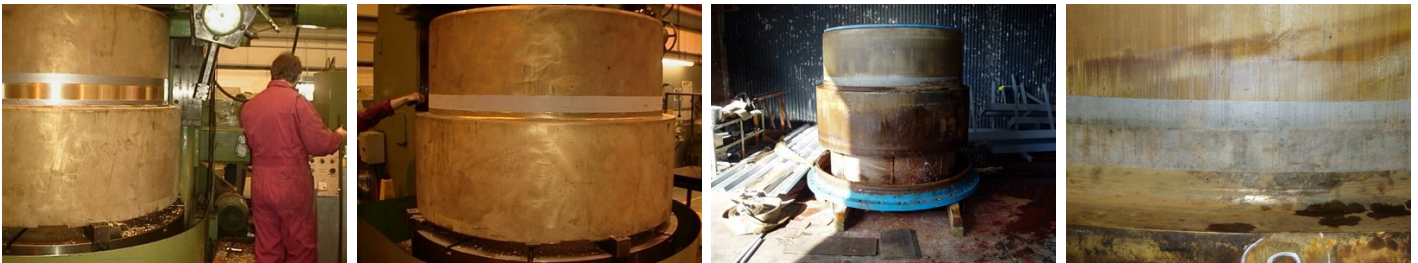
## Photograph Descriptions

- \* Piston being machined out. ,
- \* Belzona® 1111 machined to tolerance. ,
- \* Valve in for overhaul in 2007. This had nothing to do with the original Belzona repair. ,
- \* Belzona in good condition and was returned to service with no work required after passing offsite hydrostatic testing and onsite commissioning. ,

The sealing surface on the pressure relief valve had suffered damage and water was passing causing the valve not function properly.

Application was carried out in accordance with the Belzona Know-How System Leaflet MPT-1. Damaged area was machined out, filled with Belzona® 1111 then machined to tolerance.

confirming Belzona repair in good condition and suitable for return to service after already completing 9 years service.
