External Rebuilding and Protection with Belzona

ID: 9155

Industry: *Chemical & Petrochemical*
Application: *VPF-Valves, Pipes and Fittings*
Substrate: *Carbon steel*
Products: *Belzona 1161 (Super UW-Metal)*

Customer Location: *Cartagena/ Colombia*
Application Date: *October 2016*

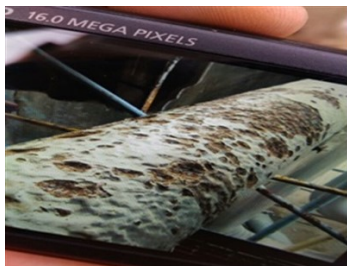
Severe corrosion on the outside of the 6" inch pipe, pitting is evident.

Pitting on pipe

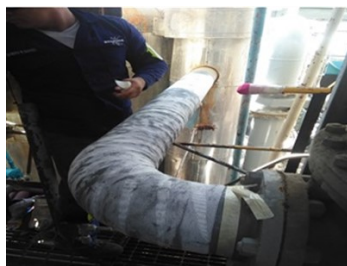
First layer of Belzona 1161 and reinforcement mesh.

The surface of the tube was prepared with a steel brush and sandpaper.

Initially the product was impregnated with a short bristle brush on the substrate, then with the applicator was given the desired thickness and a good finish.

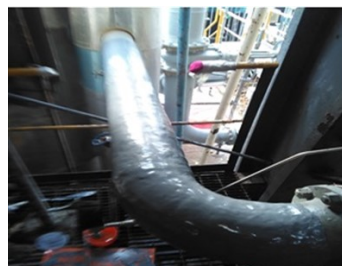
Work completed.

By rebuilding the surface with Belzona 1161, we stop the corrosion, recovered the surface and avoid the replacement of the valve section.
