# External Rebuilding and Protection with Belzona

ID: 9155

Industry: Chemical & Petrochemical  
Application: VPF-Valves, Pipes and Fittings  
Substrate: Carbon steel  
Products: Belzona 1161 (Super UW-Metal)

Customer Location: Cartagena/ Colombia  
Application Date: October 2016

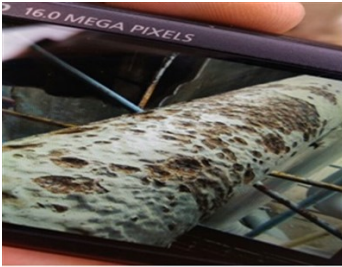
Severe corrosion on the outside of the 6" inch pipe, pitting is evident.

Pitting on pipe

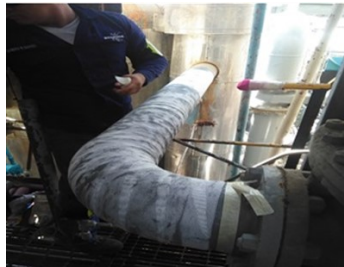
First layer of Belzona 1161 and reinforcement mesh.

The surface of the tube was prepared with a steel brush and sandpaper.

Initially the product was impregnated with a short bristle brush on the substrate, then with the applicator was given the desired thickness and a good finish.

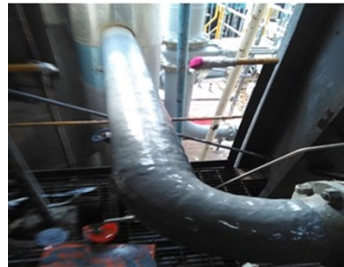
Work completed.

By rebuilding the surface with Belzona 1161, we stop the corrosion, recovered the surface and avoid the replacement of the valve section.
